Manhole Inspection Summary

Manhole # S07WW_016MH

Insp Date: **7/17/07 12:35 PM**

Location Address: **CALLAWAY AVE BETWEEN SPRINGDALE**

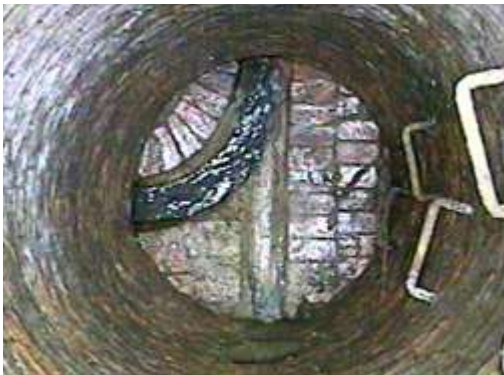
Defect 1

☒ **Evidence Of Surcharge** Depth: **3** (ft.) ☐ Active Surcharge Present

EVIDENCE OF SURGE

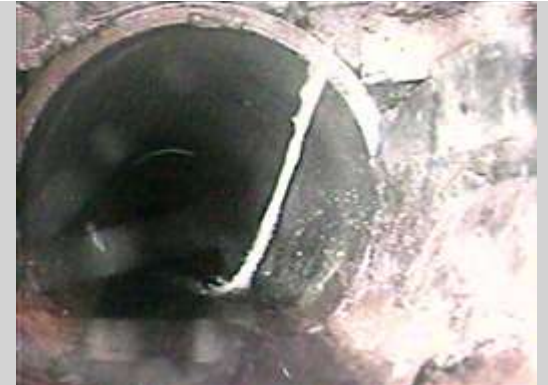
12 O'Clock Outflow

10 in. Circular Gravity Sewer
Pipe Out @ 12 O'Clock

Pipe Height: (in.) Direct
Pipe Material: **Clay** ☐ Pipe Lined
Invert Depth: **11.38** (ft.) Flow Characteristics: **Fast**
Deposits: ☒ None ☐ Mud ☐ Sludge ☐ Debris ☐ Grease
Silt Depth: (in.) Deposits Extent:
Infiltration: **None** Pipe Seal Cond: **Sound**

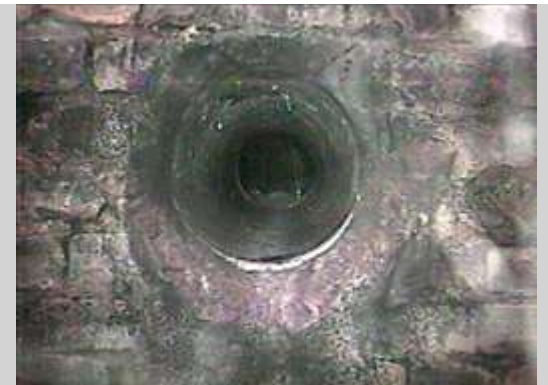
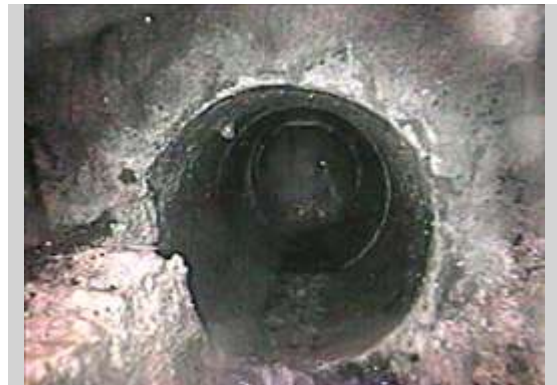
6 O'Clock Inflow

8 in. Circular Gravity Sewer
Pipe In @ 6 O'Clock

Drop In @ 6 O'Clock

Pipe Height: (in.) Direct
Pipe Material: **Clay** ☐ Pipe Lined
Invert Depth: **8.69** (ft.) Flow Characteristics: **Fast**
Deposits: ☒ None ☐ Mud ☐ Sludge ☐ Debris ☐ Grease
Silt Depth: (in.) Deposits Extent:
Infiltration: **None** Pipe Seal Cond: **Sound**

Drop: **Outside Direct**
Angled: Reading: (ft.)
Inv Depth: **10.80** (ft.)
Drop Condition: **Open**

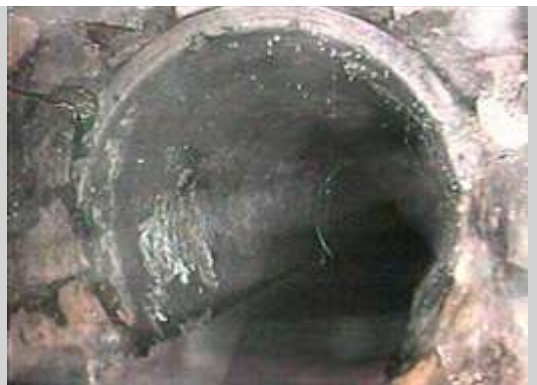
9 O'Clock Inflow

10 in. Circular Gravity Sewer
Pipe In @ 9 O'Clock

Infiltration: **None** Pipe Seal Cond: **Sound**
